PROTECTION OF AIRCRAFT FLUID SYSTEMS

LTV Aerospace Corporation

TECHNICAL REPORT AFML-TR-68-125

May 1968

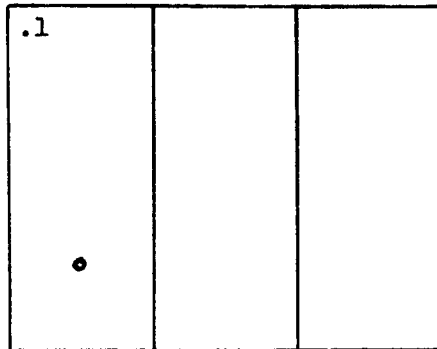
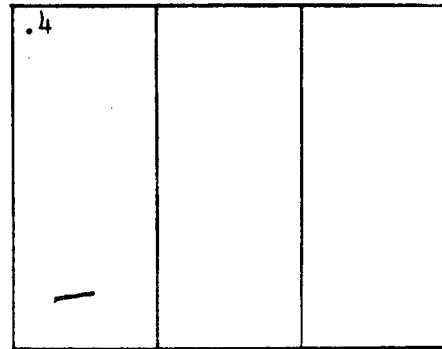
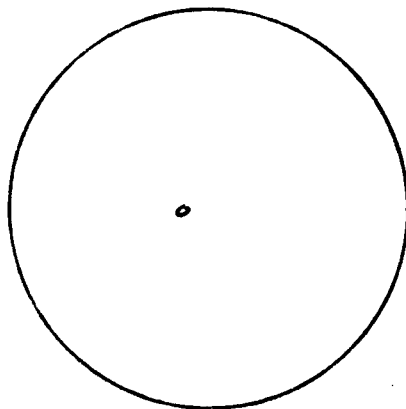
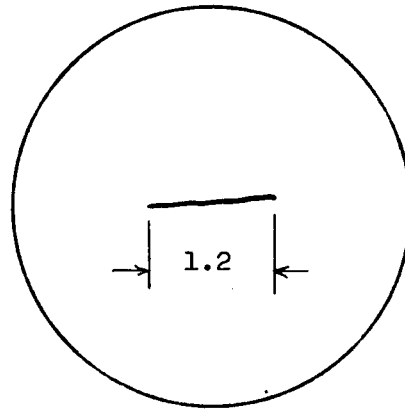
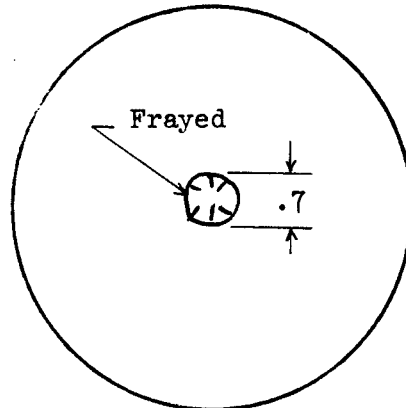
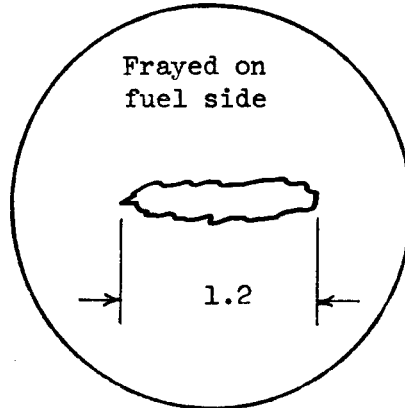
ROUND NUMBER T 43

The backing board was frayed badly. The self-sealing material leaked a small stream slowing very little in two minutes. When pressure was reduced to zero the leakage slowed to 1 drop/5 seconds constant for the rest of the test.

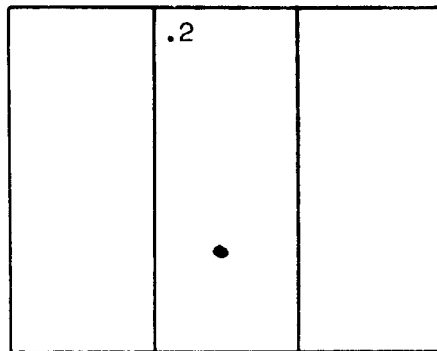
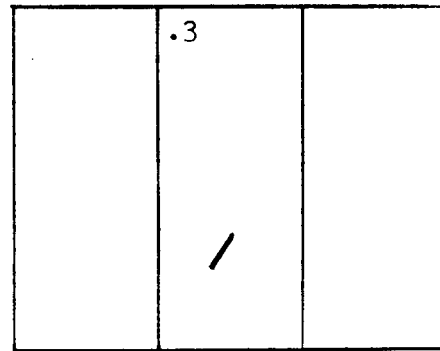
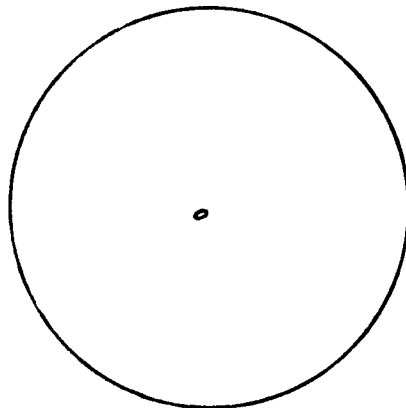
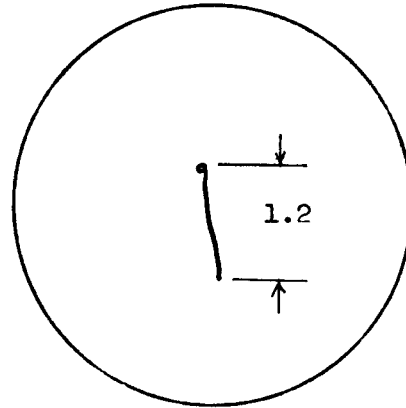
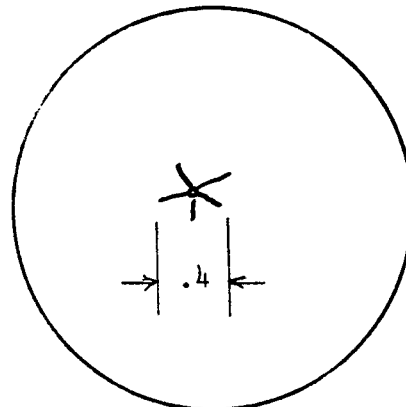
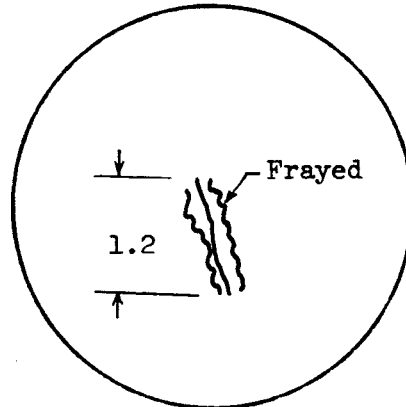
BLOCK NUMBER B 13  
ROUND NUMBER T 44

When pressurized exit wounds of T 43 and T 44 opened leaking fuel.

The round hit a wood support thus no exit was obtained. The backing board was frayed less due to the extra support from the wood. The self-sealing material was slit and leaked a drippage rate. When pressure reduced to zero the wound continued to seep for the rest of the test.

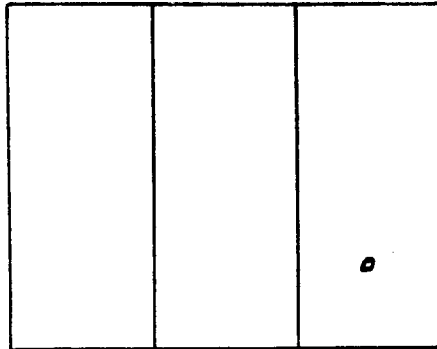
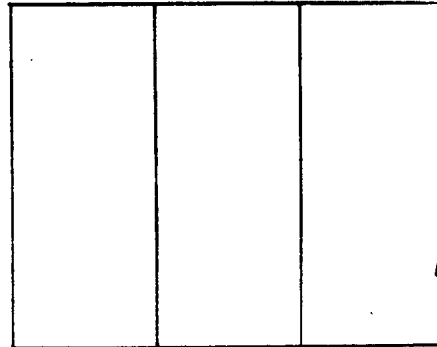
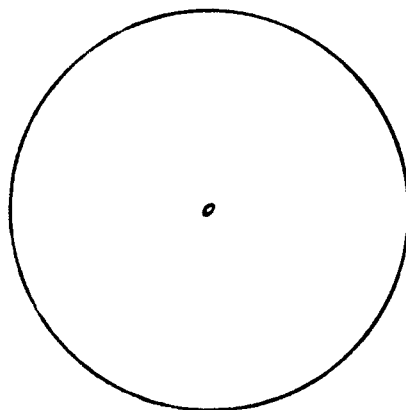
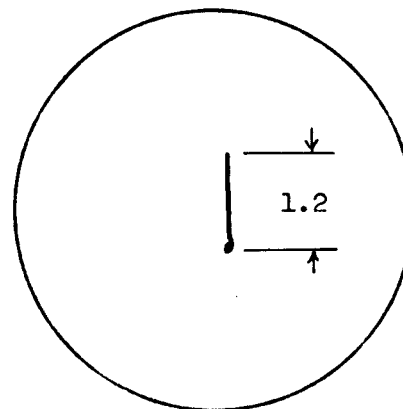
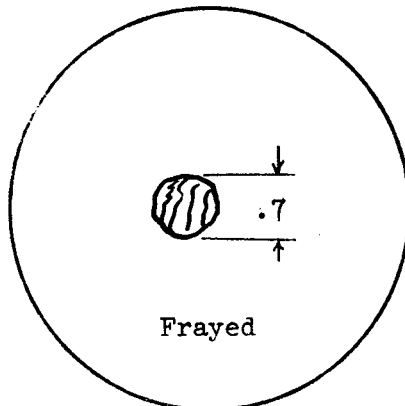
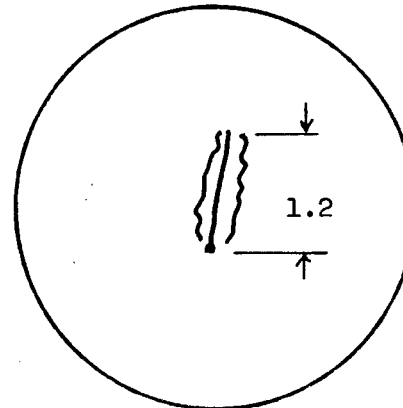
ROUND NUMBER T 45

The backing board was penetrated but the self-sealing material was only cracked.

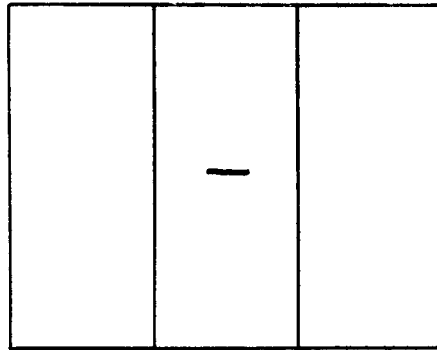
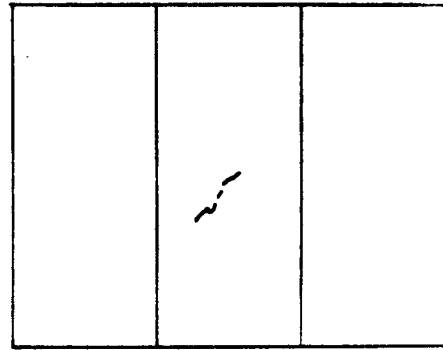
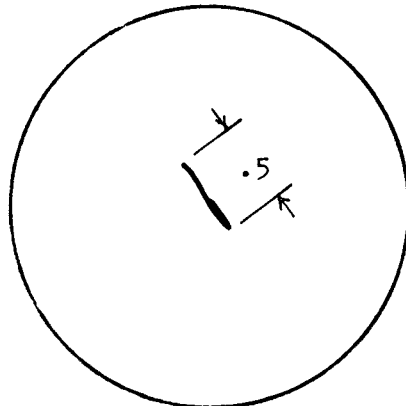
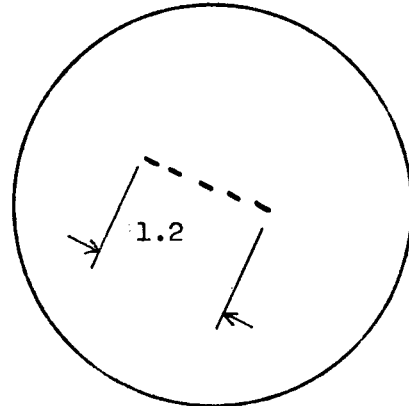
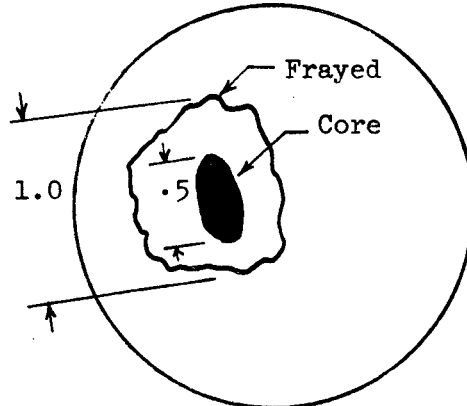
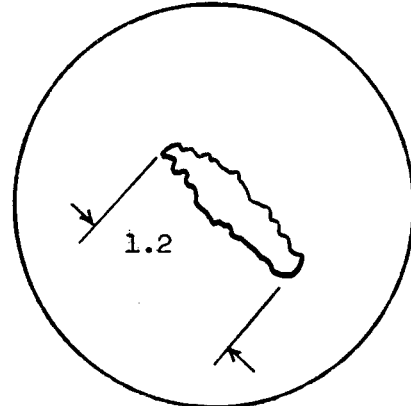
BLOCK NUMBER B 13  
 ROUND NUMBER T 46

The backing board was frayed and cored badly. The self-sealing material was cored badly and misaligned some. Fueled tank to a higher fuel height at zero pressure. Both exit and entrance wounds leaked with no reduction of rate in 2 minutes. Leakage rate was 4 gallon/minute. Upon disassembly of the tank, self-sealing material corings were found inside.

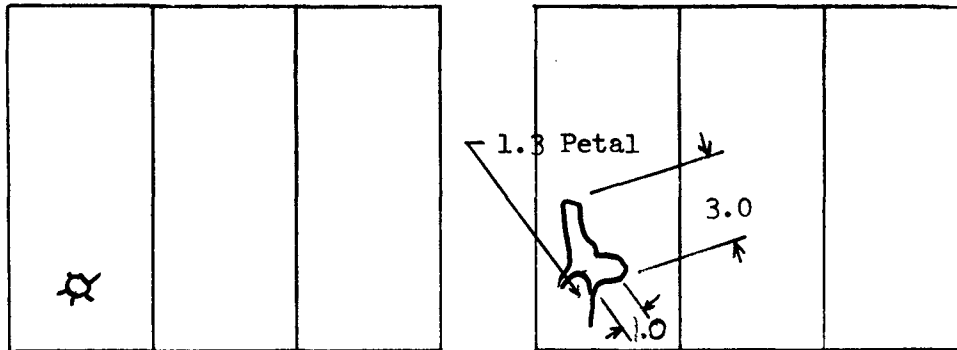
The skin was cored and petaled. Backing board was frayed to a diameter less than the projectile diameter. The self-sealing material showed no trace of fuel leakage.

The skin was cored and petaled. The backing board was frayed. The self-sealing material was sealed damp in 30 seconds and sealed dry shortly after. The support angle on the exit panel failed and moved out approximately 1.50 inches. However, the support angle failure did not seem to affect the sealing time, so the test was continued with no changes. Clamps held but allowed the flanges to leak.

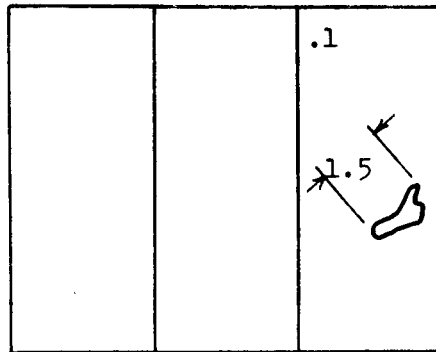
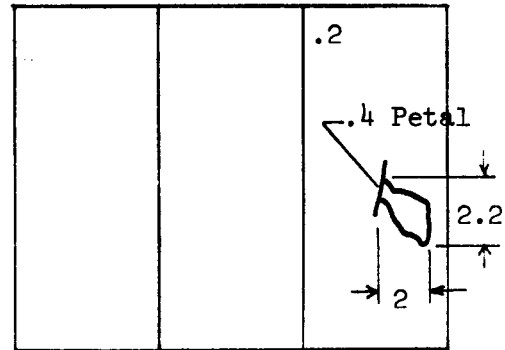
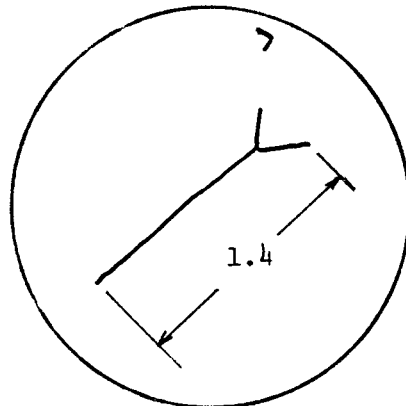
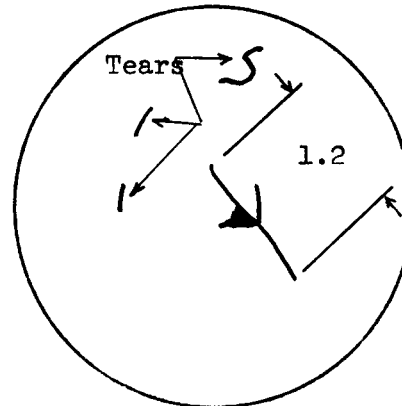
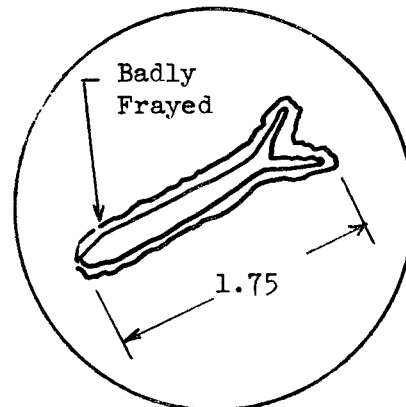
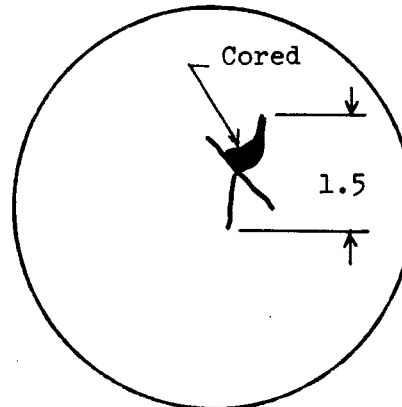
BLOCK NUMBER B 26  
 ROUND NUMBER T 50

A large flash was seen on entrance. Skin cored and petaled .3 inches. The backing board split and frayed badly. The self-sealing material flowed fuel for 1.5 minutes obtaining a damp seal at 2 - 2.5 minutes and a dry seal in 6 minutes. The material was cored slightly. Total leakage was .5 gallon from wound.

The skin was tested with the nose and tail of the projectile splitting the skin. The projectile then bounced back into the fuel box. The backing board was only slightly damaged with no loss of support. The self-sealing material obtained a damp seal immediately.

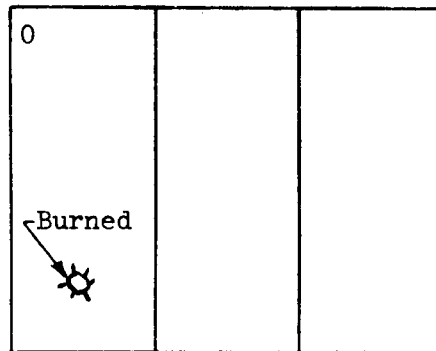
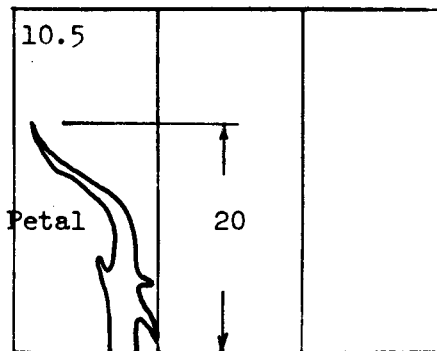
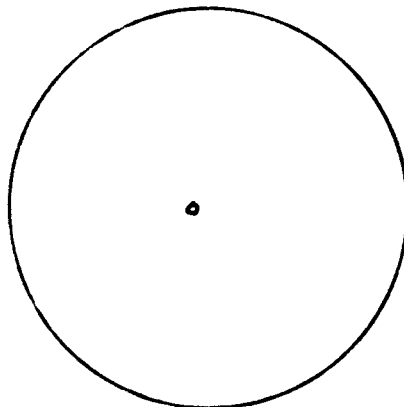
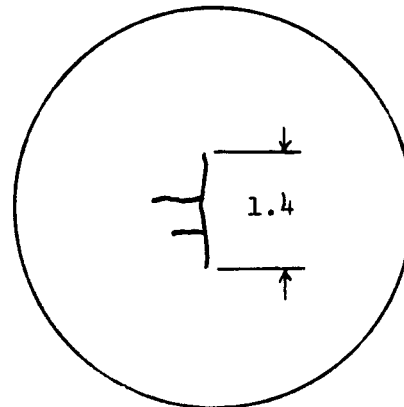
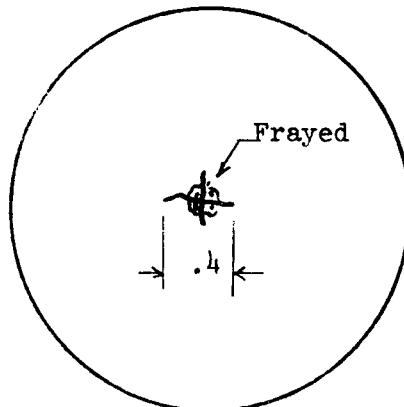
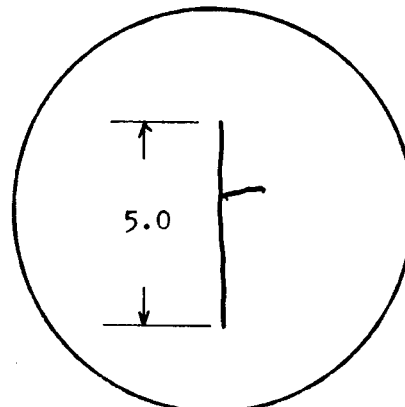
When tank was impacted by the projectile the flanges let go, thus the pressure went from 2 psi positive to a vacuum. The skin was cored and petaled with metal corings stuck in the backing board. The self-sealing material leaked slightly but obtained a damp seal in less than 1 minute.

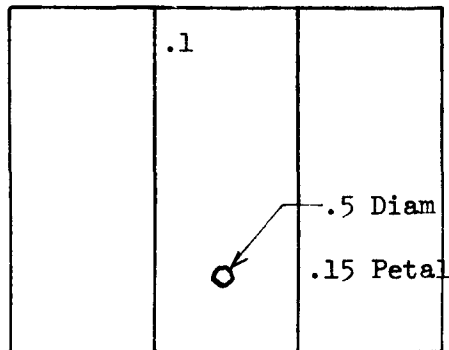
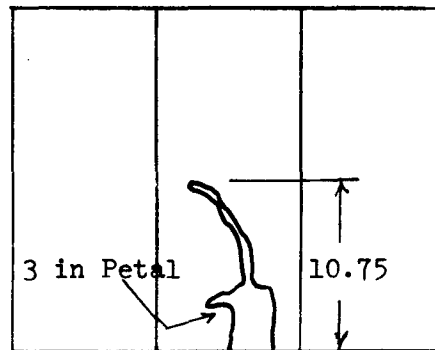
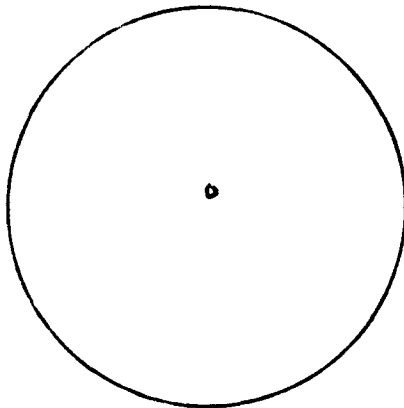
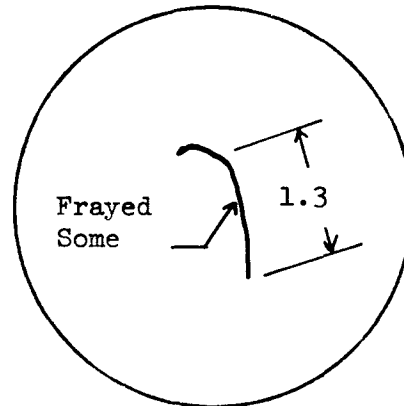
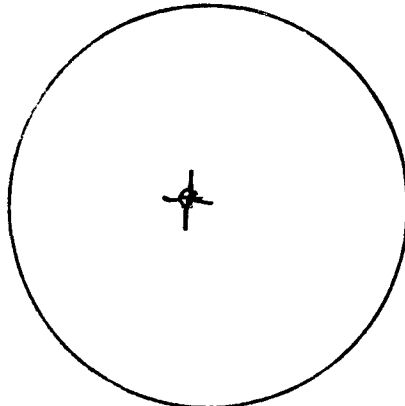
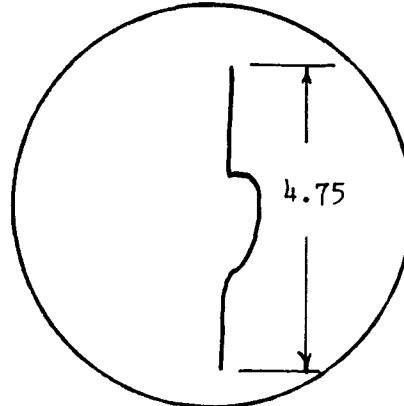
ROUND NUMBER T 53

The skin was cored and petaled. The self-sealing material obtained a damp seal immediately at 1 psi. The backing board held fine with little damage.

The skin was cored and petaled 2.25 inches maximum high. The projectile split the backing board and self-sealing material. The self-sealing material leak would slow only when the pressure was reduced. Rates were .25 gallon/minute 1 psi and dripping at zero psi.

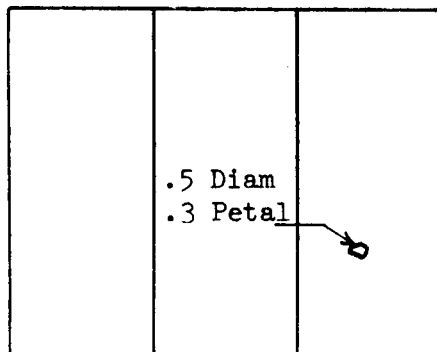
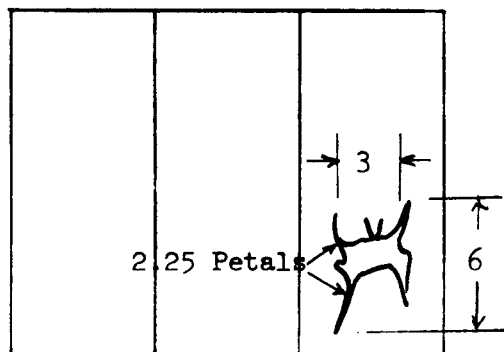
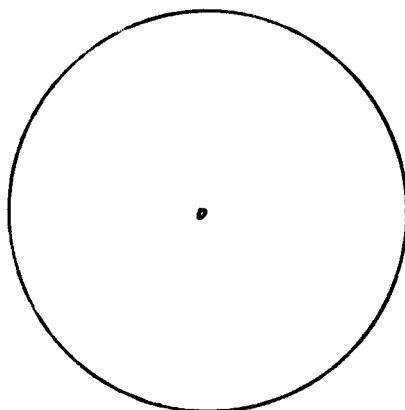
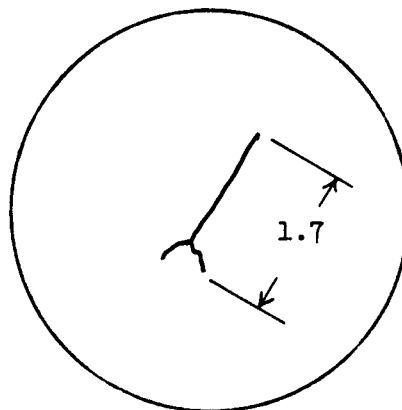
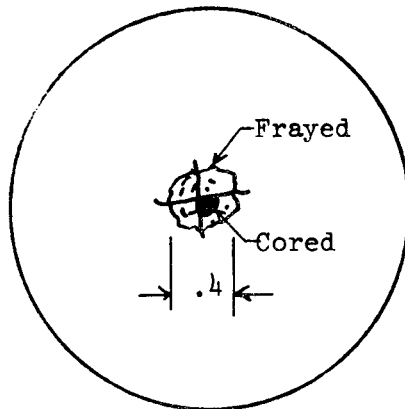
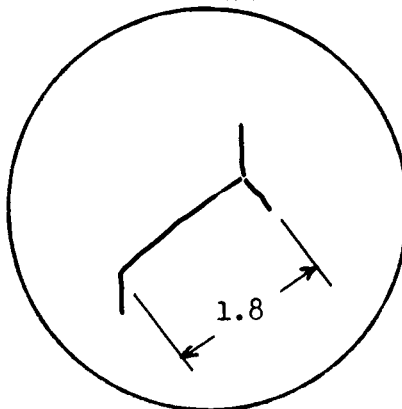
BLOCK NUMBER B 34  
 ROUND NUMBER T 54

The skin was cored and badly shattered. The backing board was frayed and cored. The self-sealing material was also cored slightly but cut badly. The leakage was 3/4 gallon/minute constant at zero pressure.

The skin was dented. The backing board just had one hole in it. The self-sealing material had two cuts but neither showed any sign of leakage. When the cell was torn down the following was found inside:

Projectile broken in two pieces, skin coring, self-sealing material and backing board corings.

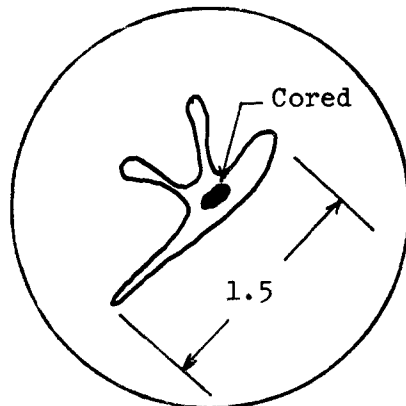
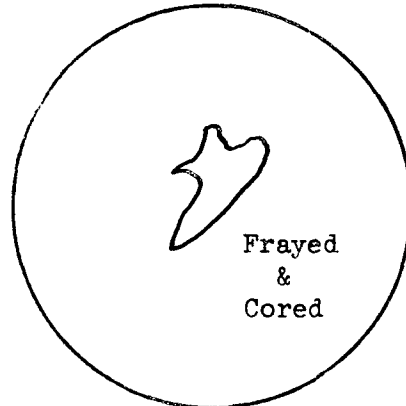
The skin was cored some with much petaling and cracks. The petals were .25 inches high and rolled over. The backing board was frayed for approximately .5 inches diameter. The self-sealing material was dry with no trace of fuel.

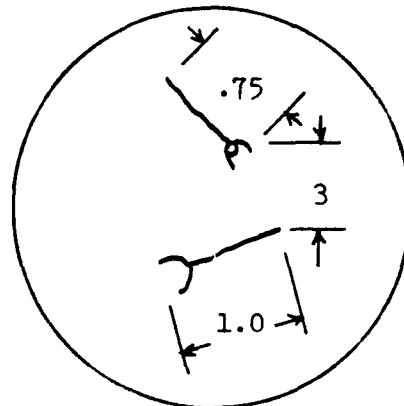
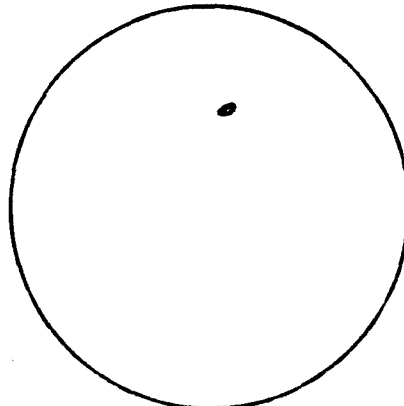
The skin was torn, cored and petaled to 2.75 inches. The backing board was restrained and was torn to pieces (three tears from bottom to top and part missing).

The self-sealing material was pulled into the box and the wound was misaligned thus wound flowed full flow until box emptied. The exit flange was removed and the edges of the wound realigned. The material sealed then with no leakage at 2 psi of Nitrogen. The exit wound would have sealed if supported by the backing board.

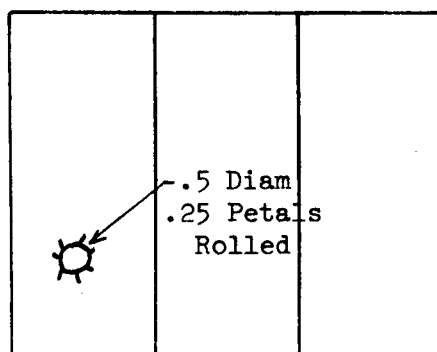
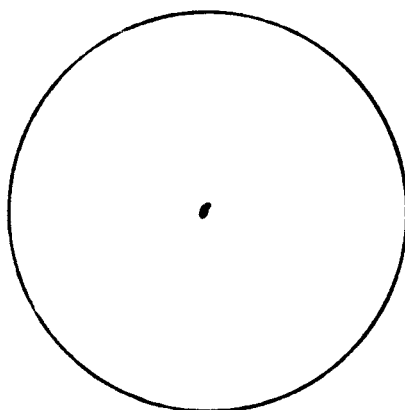
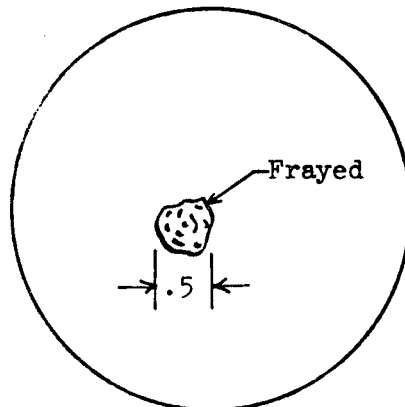
ROUND NUMBER T 56

The skin was cored and petaled to 3.75 inches. The backing board was split, failing totally. Also the backing board was floated in the skin. The failure was very similar to that of the previous shot with the restrained backing board. So no improvement is accomplished by floating the backing board. The self-sealing material wound edges were misaligned, thus no possibility of sealing. The wound would have sealed though, if supported and the wound edges were aligned.

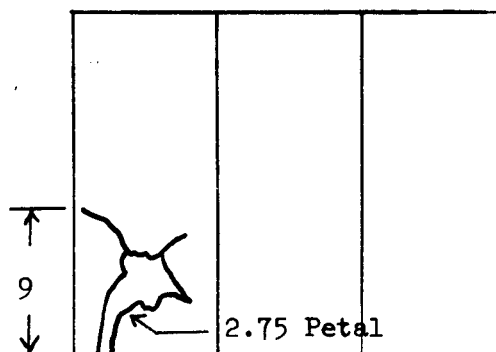
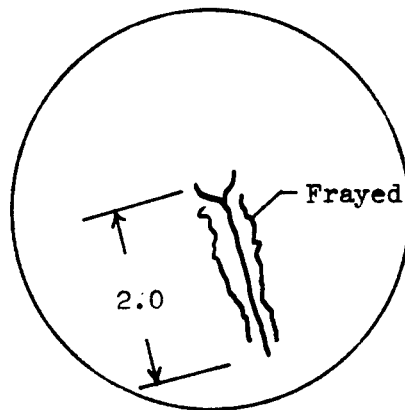
Total Loss:  
Three tears from  
bottom to top. Area  
around the wound  
10 x 15 in. totally  
removed.

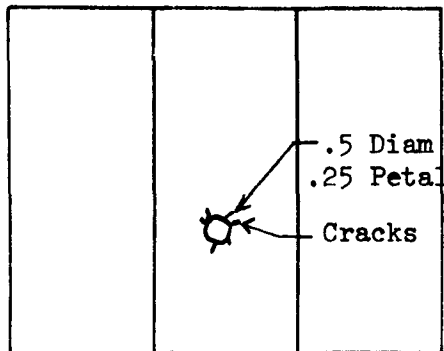
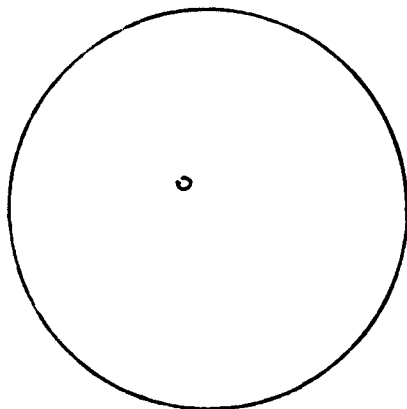
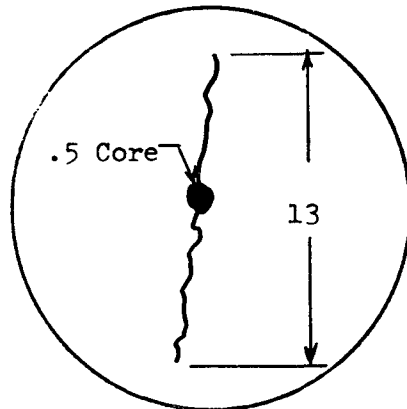
ROUND NUMBER T 57

The skin was cored and had a .4 inches high petal. The backing board was only frayed. The self-sealing material was cracked and supported by the skin petal but obtained a damp seal immediately. The wound leaked enough to only dampen the surfaces; no drips.

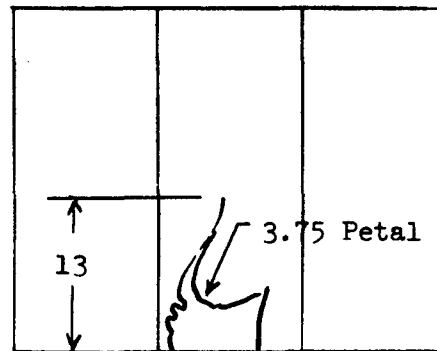
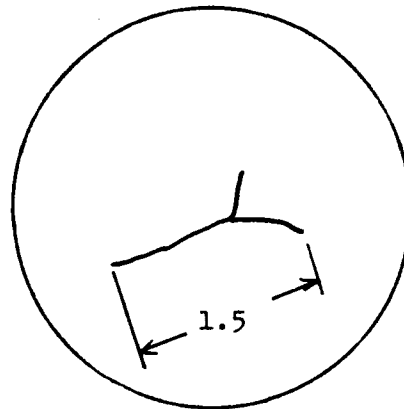
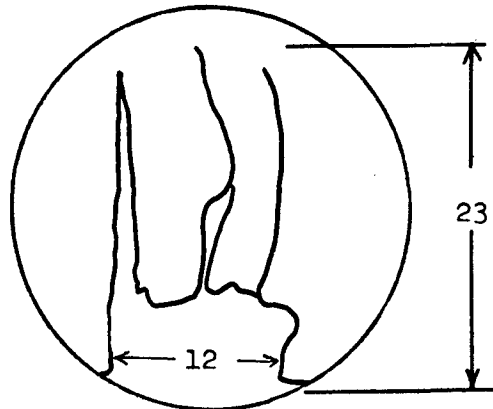
The skin was cored and petaled to a height of 2.3 inches. The backing board was floated and was only frayed. The self-sealing material was pulled into the box enough to buckle and misalign the edges of the wound thus no seal was possible. The material was cracked badly but only had a 1 1/2 gallon/minute constant leakage rate.

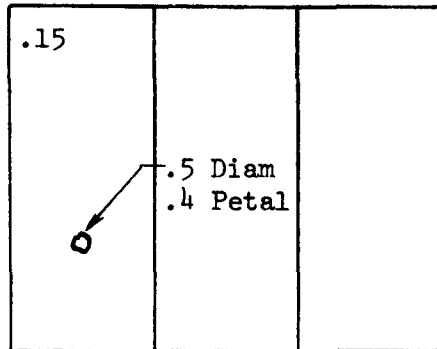
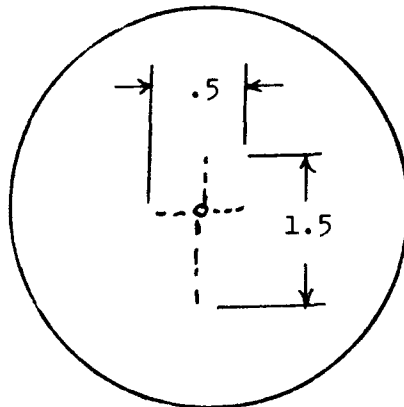
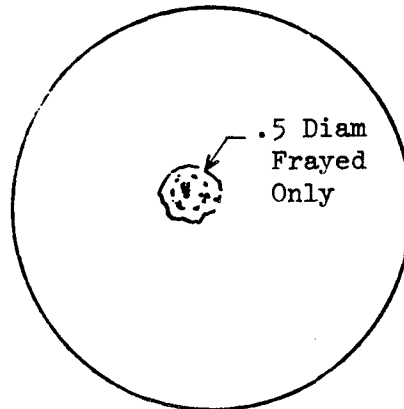
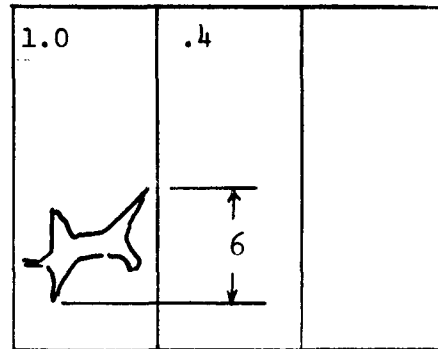
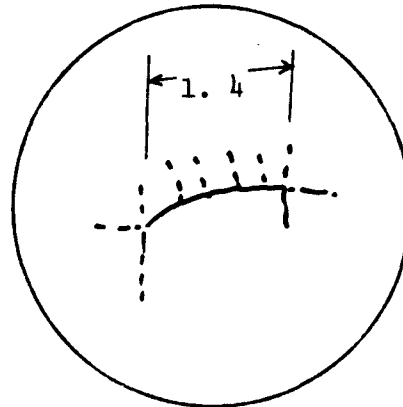
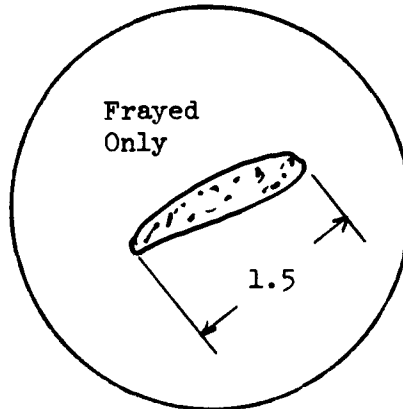
ROUND NUMBER T 58

The skin was cored and petaled to a height of 1.5 inches. The backing board was frayed with very slight coring. The backing board floated. The self-sealing material was split and cored on the fuel side some. The leakage flowed approximately 1/2 the size of a pencil for 1.5 minutes and slowed to a damp seal in 2.5 minutes. Total fuel lost was on the order of 1/4 gallons.

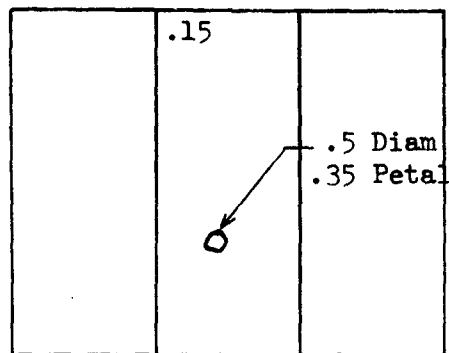
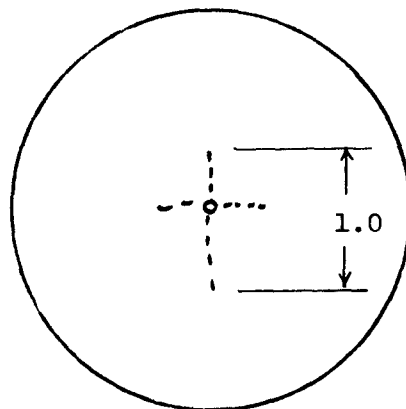
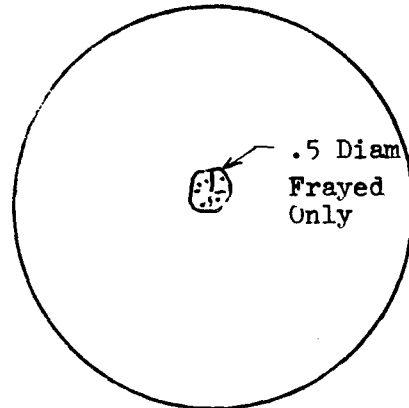
ROUND NUMBER T 59

The skin cored and petaled .35 inches high. There was no problem of holding the wound open though. The backing board was only frayed to the diameter of the projectile. The self-sealing material flowed fuel for approximately 1 minute before obtaining a damp seal. The leakage quantity was very small.

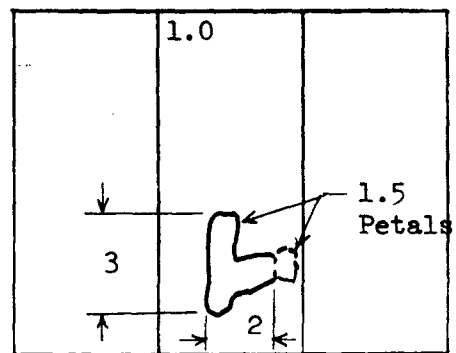
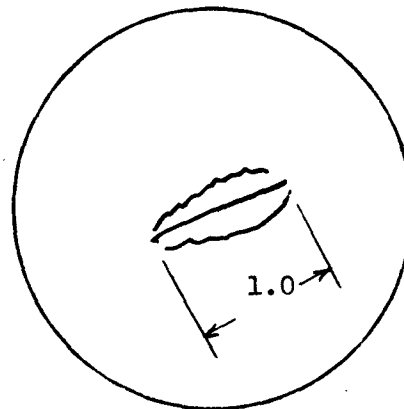
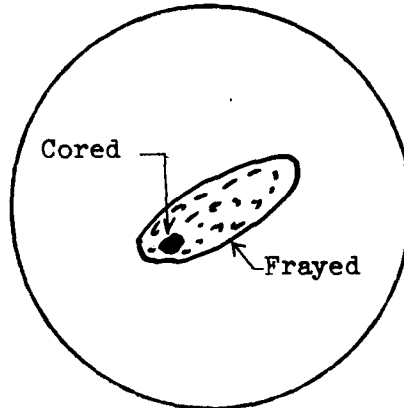
The skin was split and petaled to 1.5 inches high but no coring occurred. The backing board on exit side only was floated and was split the length of the projectile with both fraying and coring occurring. However, support was still maintained for the self-sealant material. The self-sealing material was slit and was frayed. The leakage was not measurable but was a fast dripping rate slowing to a damp seal in 2 1/2 minutes.

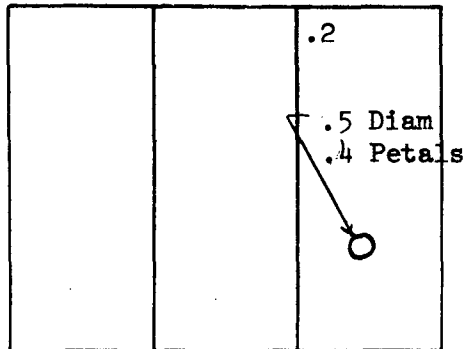
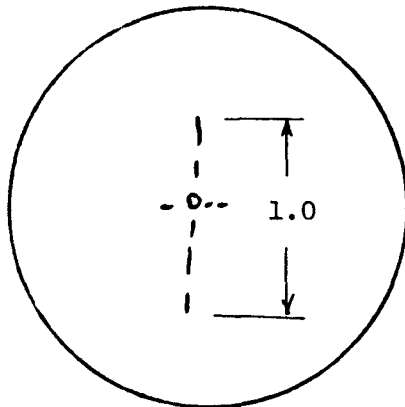
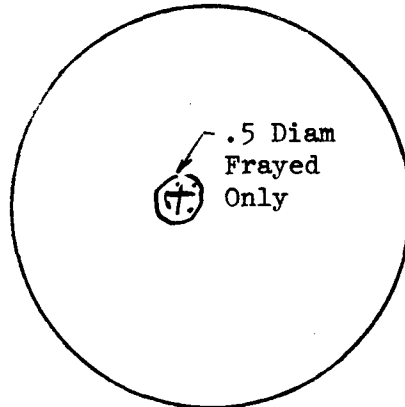
ROUND NUMBER T 60

The skin was cored and split. A large flash occurred upon impact by projectile. Fuel was noted to spray out through the flash. The backing board was cored to the size of a tumbled projectile. The self-sealing material was slit and cored slightly. The leakage was full flow for approximately 30 seconds and reduced to a rate of 1/4 gallon/minute after 3 minutes.

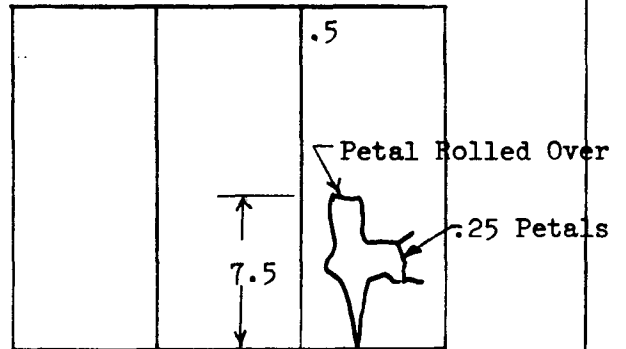
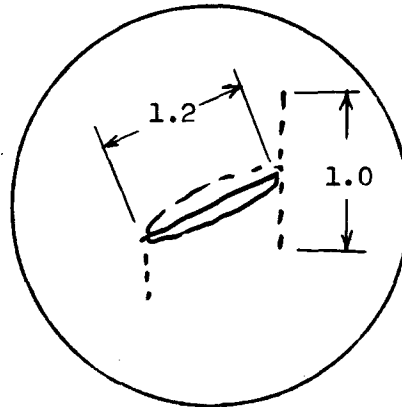
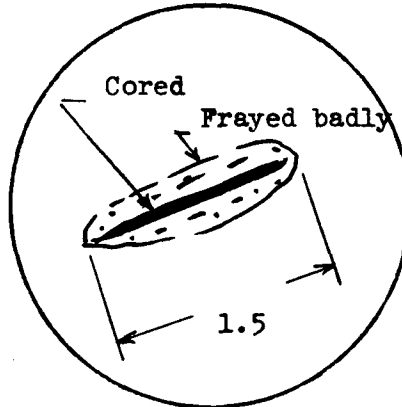
The skin was petaled but not cored. The backing board was split the length of the projectile with slight fraying. The self-sealing material was dry immediately with no trace of fuel. The projectile nose was found inside the box along with skin and self-sealing material corings when disassembled.

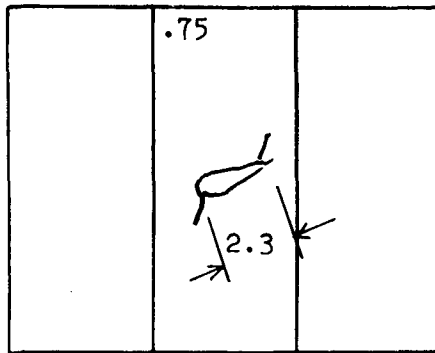
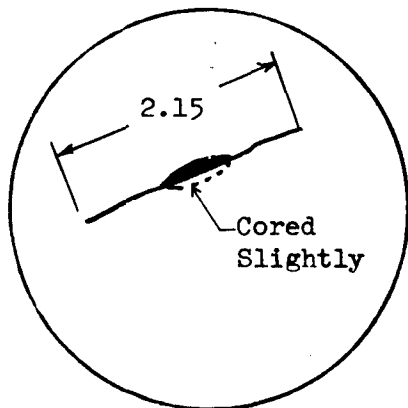
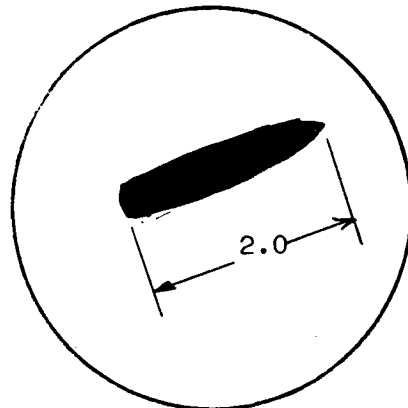
ROUND NUMBER T 61

Entrance: Small flash on entrance. Straight 11 inches below fuel surface. The skin was cored and petaled to .30 inches. However, the petal did not hold wound open. The backing board was only frayed to the size of the projectile. The self-sealing material was cracked but no coring and sealed with only a trace of fuel leakage. The self-sealing material had the impact of the backing board fiber in it from the shock load.

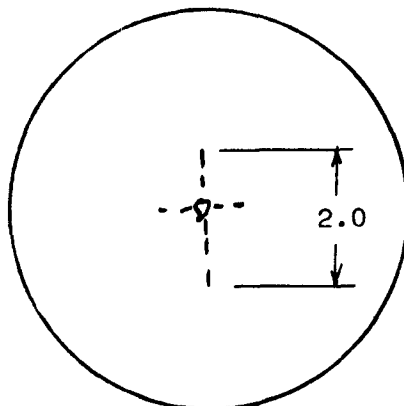
ENTRANCE

The skin was cored and petaled a height of .2 inches; petals rolled also. The backing board was only frayed. The self-sealing material was dry with no trace of leakage. The petaling did not affect the sealing material.

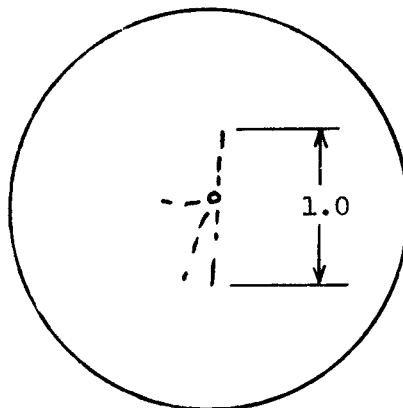
ENTRANCE

The skin was petaled .2 inches high with all petals rolled over. The backing board was only frayed to diameter of the projectile. The self-sealing material obtained a damp seal immediately. However, the box lost pressure immediately on impact due to exit side failure.

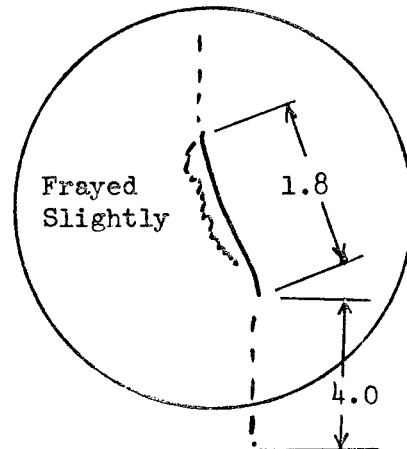
EXIT

The skin was cored and petaled 3.5 inches high maximum. The backing board was frayed only in the projectile wound but once again was pulled into the skin deflection area and no support was given to the self-sealing material. The self-sealing material wound was misaligned, thus no seal was possible. The leakage rate was 5 gallon+/minute at zero pressure.

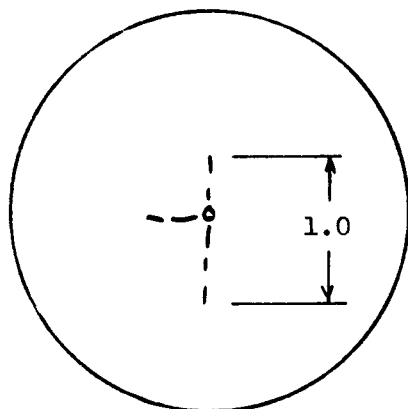
ENTRANCE

Skin flashed as it was impacted by projectile. The skin was cored and petaled 0.4 inches maximum. Backing board was cored and frayed to size of projectile. The self-sealing material sealed damp immediately with only a trace of fuel leakage.

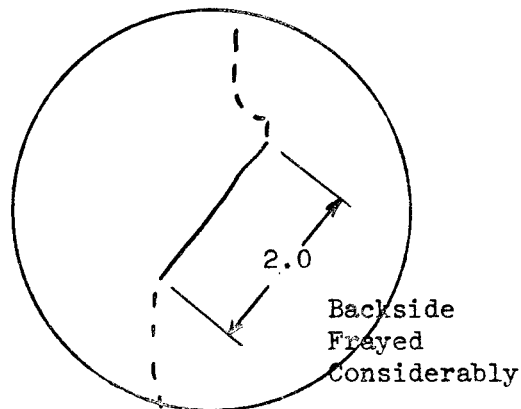
EXIT

The skin cored and petaled greatly. Some petaling rolled over slightly. The backing board total failure with 3 splits from top to bottom with other smaller tears. The self-sealing material would not seal without support from a scale and leaked constantly, with zero pressure, at 1-2 gallon/minute. The failure was due to the backing board failing.

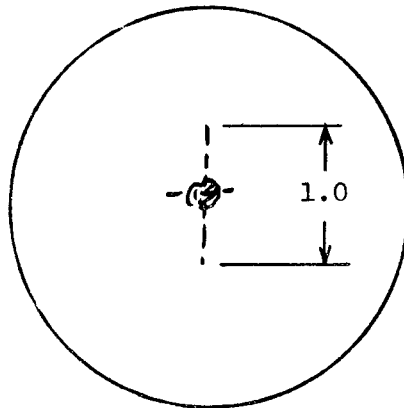
ENTRANCE

The skin was cored and petaled. The backing board was just frayed to diameter of projectile. The self-sealing material sealed dry immediately with no trace of fuel leakage.

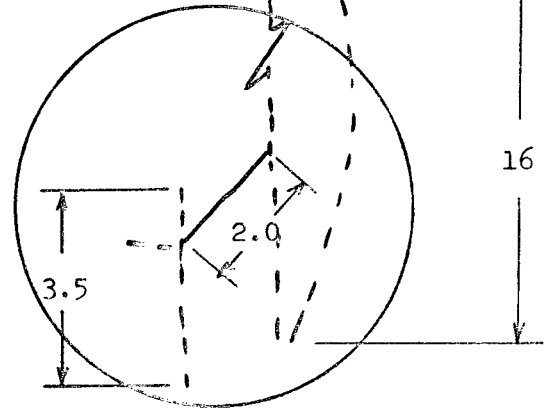
EXIT

The skin was cored and petaled. One petal was 11 inches long and rolled over so that it was only 4 inches high. The backing board was torn 13 inches long and 4 inches across with some coring. The self-sealing material was torn 13 inches long and 4 inches across, but was not cored. Some fraying was present in the cloth. The self-sealant was well activated. The tank was emptied in approximately 2 minutes. Leakage was photographed at 2 minutes. Leakage rate was approximately 25 gallon/minute.

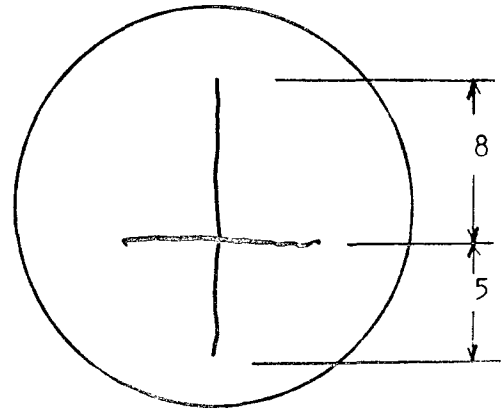
EXIT

The skin was cored, petaled and split out giving no support to the backing board. The backing board fiber was split but the ARM material was intact. The self-sealing material was split, frayed and cored slightly. The backing board and self-sealer was misaligned. If this had not happened the material might have sealed. Leakage rate was 2-3 gallon/minute.

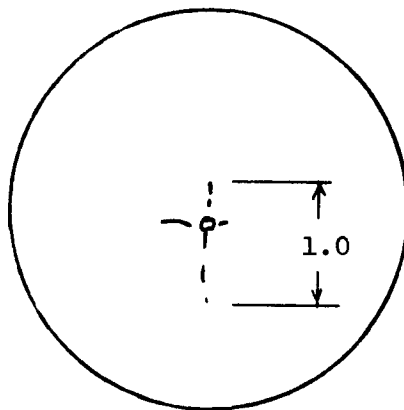
ENTRANCE

The skin **flashed** as it was impacted by the projectile and was cored with slight petaling. The backing board was just frayed. The self-sealing material sealed dry with only a trace of fuel leaking out at impact.

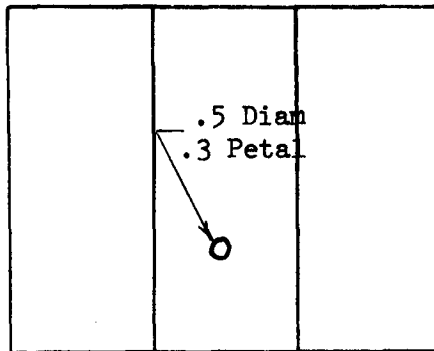
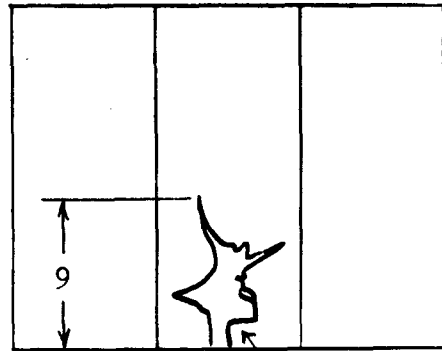
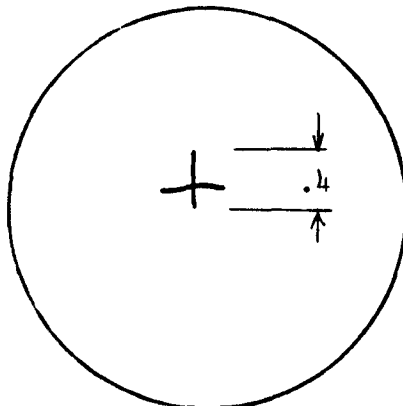
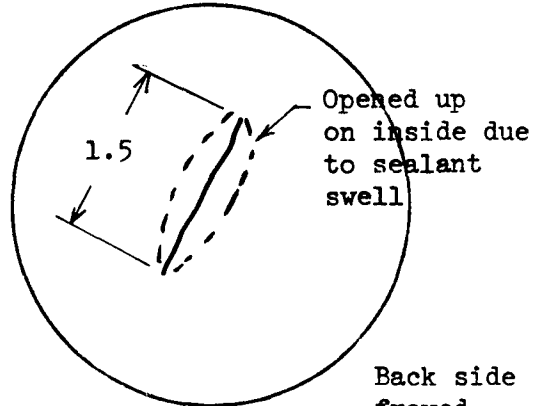
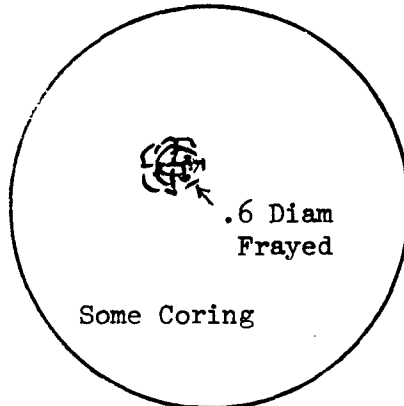
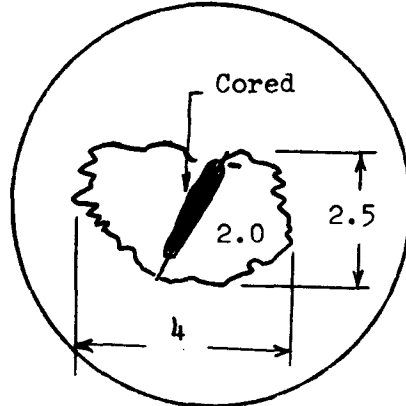
ROUND NUMBER T 69

Entrance: Flash observed. Straight 13 inches fuel head.

The skin petaled with a very small amount of coring. The petals rolled over and the backing board frayed and cored. The self-sealing material leaked at a constant trickle until the pressure was reduced to zero. The wound then dried.

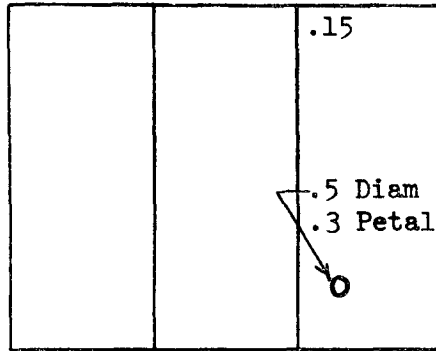
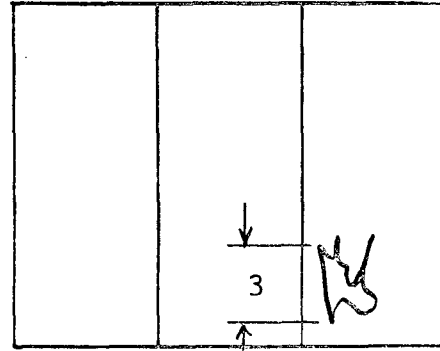
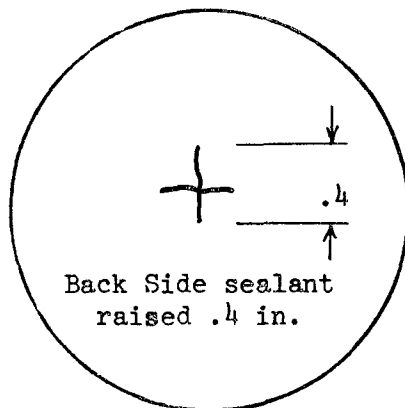
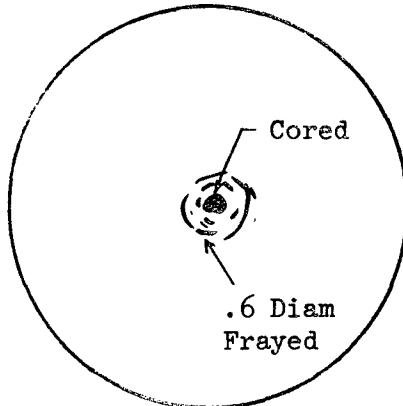
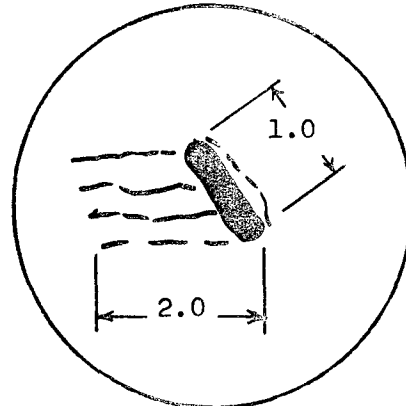
ROUND NUMBER T 70

Entrance: Tumbled 61 inches below fuel surface. Flash observed on skin.  
The skin cored with no petaling. The backing board frayed and cored.  
The self-sealing material leaked a small stream 1/4-1/2 gallon/minute slowing to a trickle in 3 minutes.

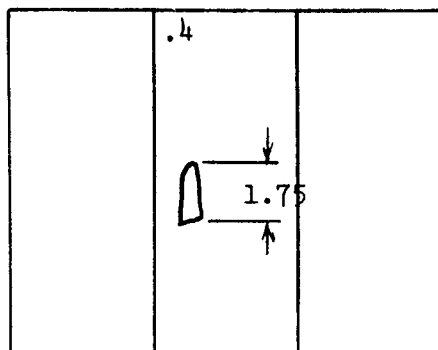
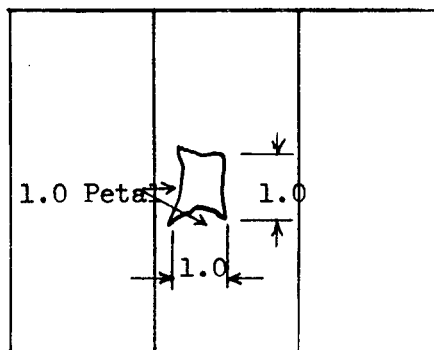
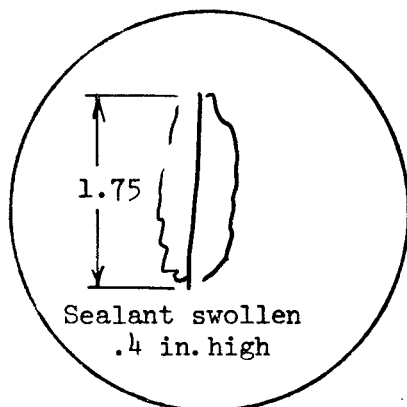
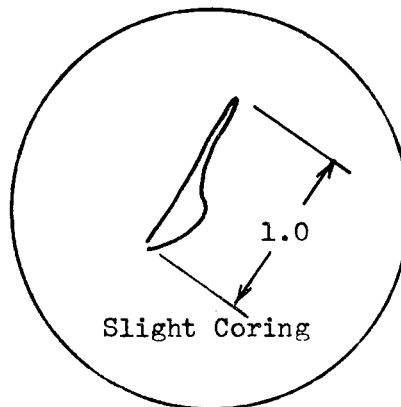
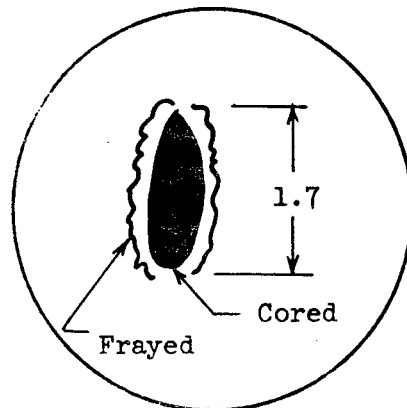
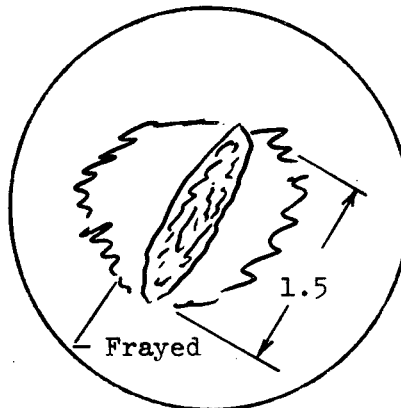
ROUND NUMBER T 71

Back Side  
Sealant  
raised  
.4 in.

Entrance: Observed flash on entrance. Projectile failed to tumble. Impacted below 5 inches fuel.

The skin was cored and petaled to 1.75 inches high. The projectile exited next to a wood support and struck the steel support angle. The backing board frayed. The self-sealing material was misaligned so no seal was accomplished. After 2 minutes the leakage was constant at 1.5 gallon/minute under 2 psi. When the pressure was reduced to zero the leakage slowed to just a trickle. The projectile impact opened exit wounds T 70, T 71, T 69, entrance T 71 damp.

On disassembly of box, found brass, aluminum, and some self-sealing inside.
